PART B - REQUIRED ITEMS IN CONDUCTING TP-201.3 FOR PERMEATOR INSTALLATIONS

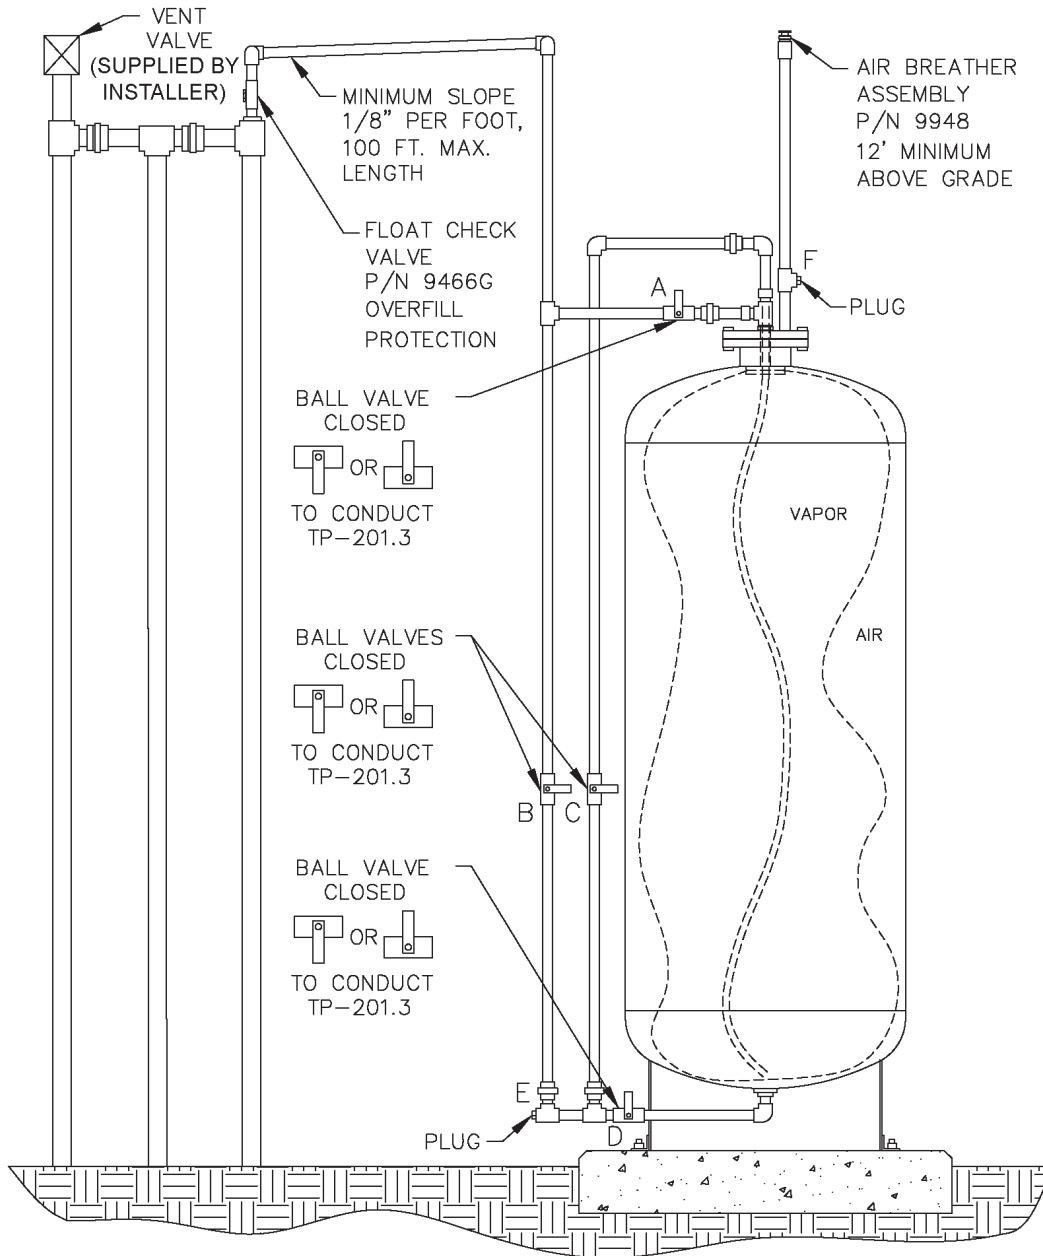
FIGURE 8-1
Configuration of Healy Clean Air Separator to Conduct TP-201.3

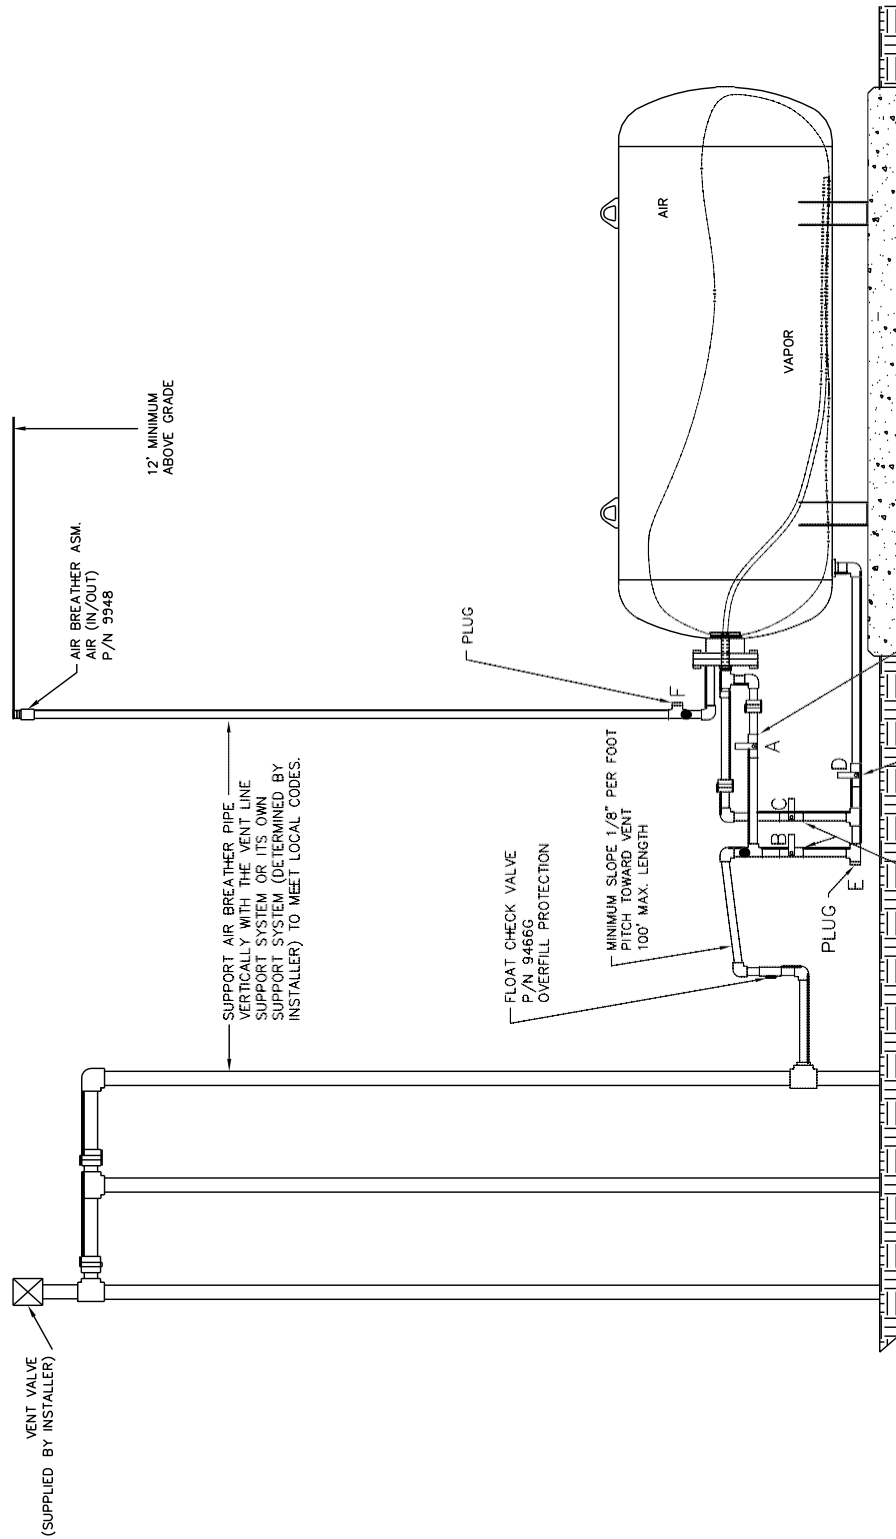
FIGURE 8-1H
Configuration of Healy Clean Air Separator to Conduct TP-201.3

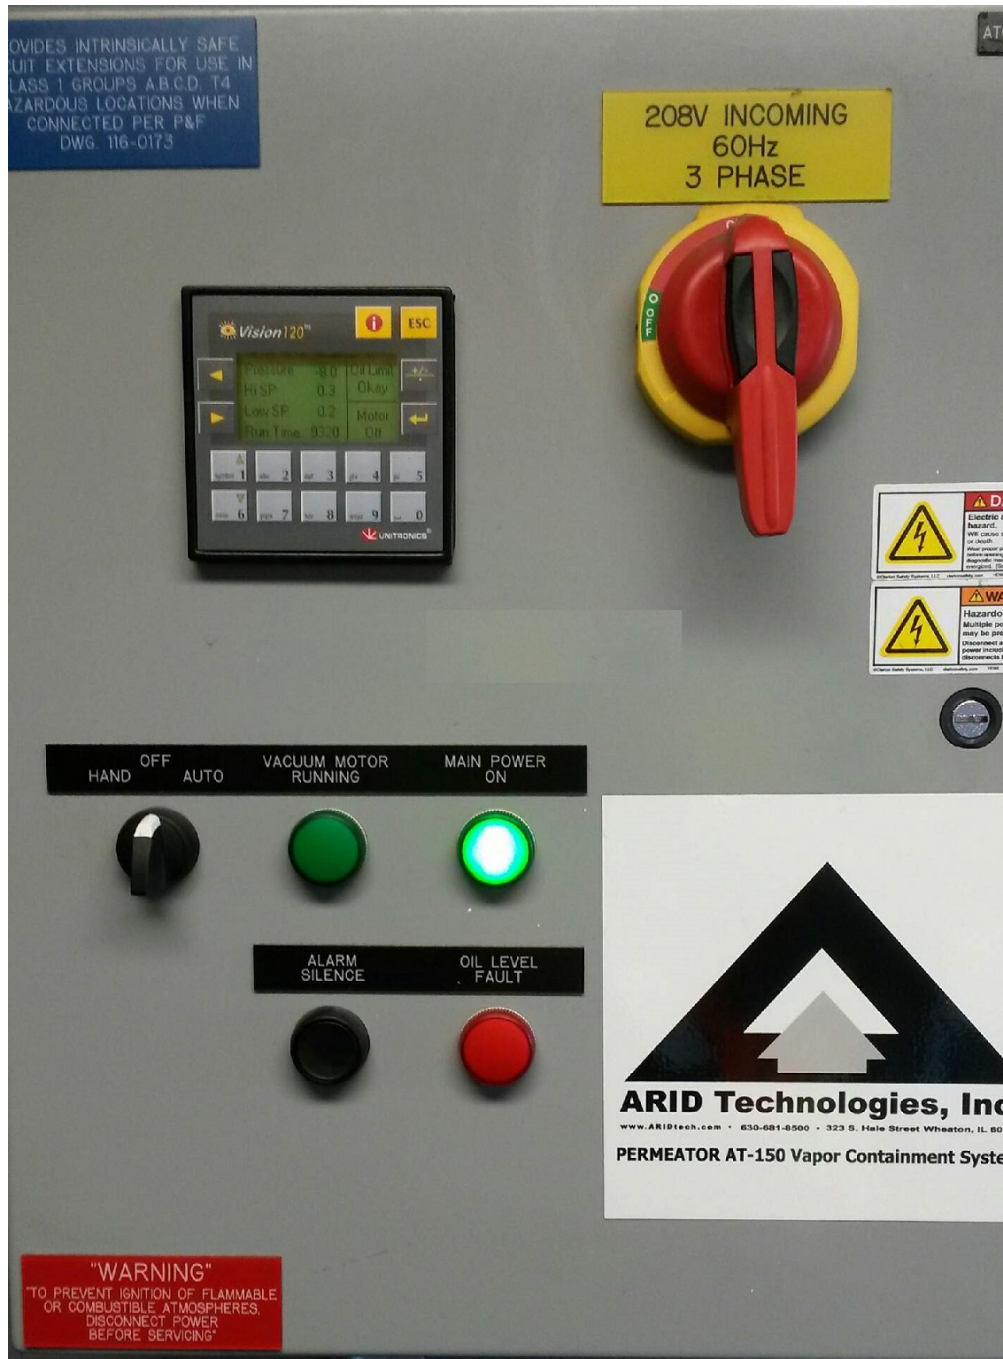
FIGURE 8-2
Configuration of Permeator Control Panel Hand/Off/Auto
Control Knob in OFF position to Conduct TP-201.3

1. Prior to conducting TP-201.3, the Permeator should be in the OFF position by turning the Hand/Off/Auto knob on the Control Panel Mounted Inside the Station Kiosk, as shown in Figure 8-2.
2. Conducting TP-201.3 with any dispenser piping test valve in the closed position is **not** permitted. Any dispenser with a dispenser piping test valve in the closed position while conducting TP-201.3 will bias the test towards compliance.
3. After conducting TP-201.3, the Permeator should be switched back into the AUTO position by turning the Hand/Off/Auto knob on the Control Panel Mounted Inside the Station Kiosk, as show in Figure 8-3.

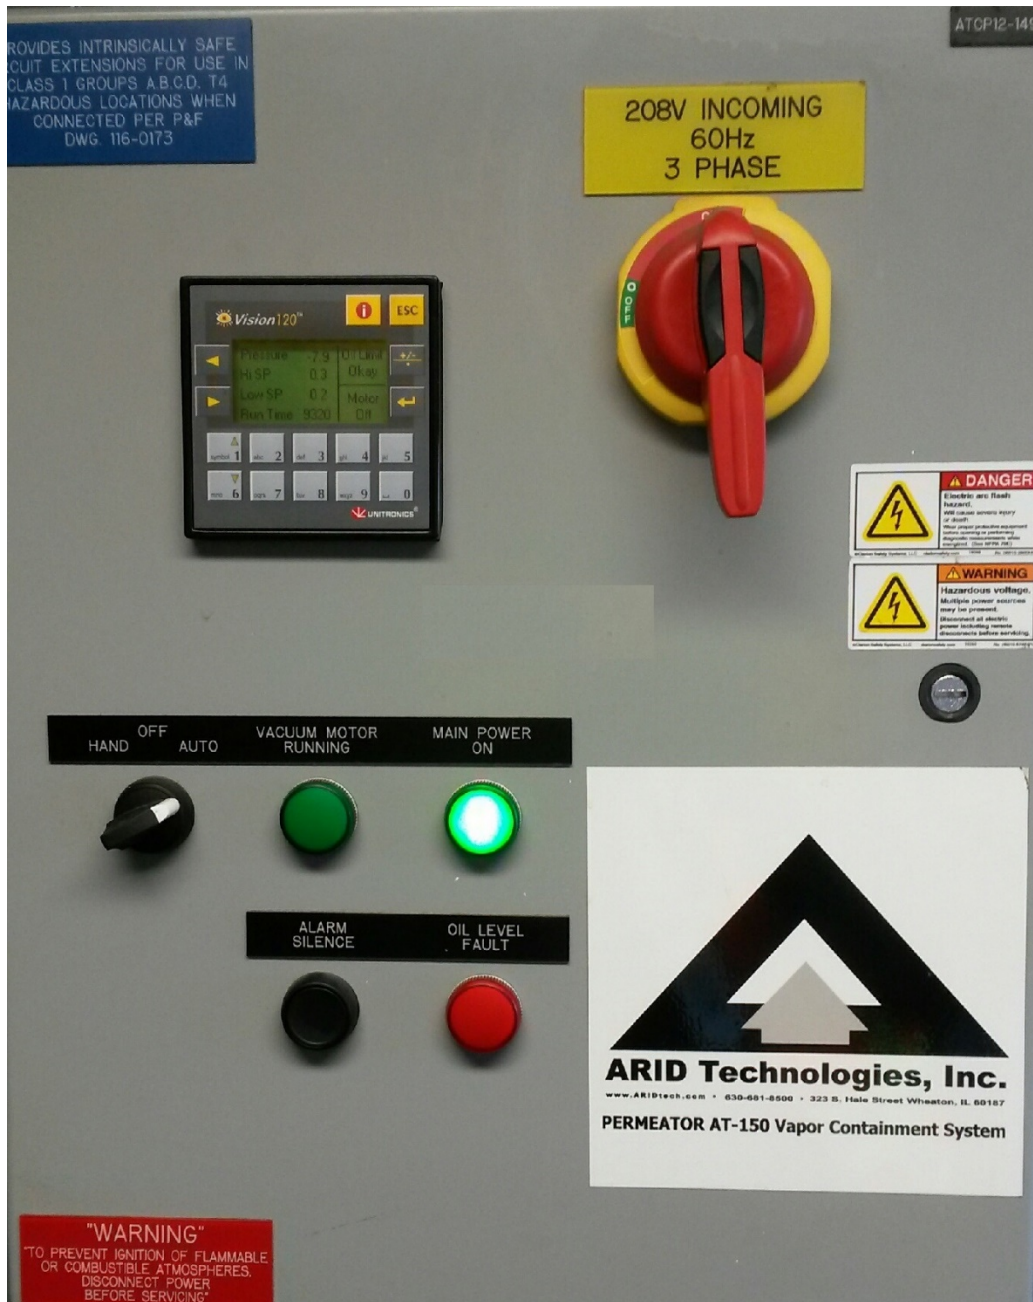
FIGURE 8-3
Configuration of Permeator Control Panel Hand/Off/Auto
Control Knob in AUTO position after Conducting TP-201.3
